# Manhole Inspection Summary

Manhole # S47GG\_020MH

Record Plat: **47GG** Node: **020** Status: **Found**

**Location** Address: **Preston**

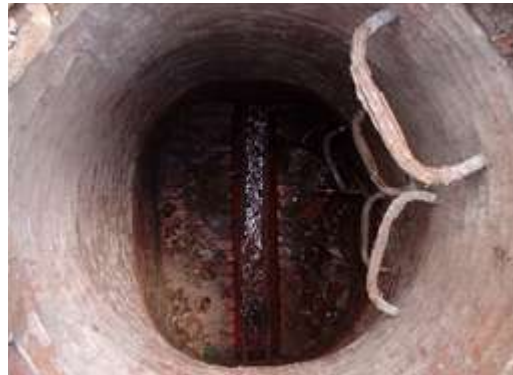
Top View

**Frame** Offset: **2** (in.) Condition: ☐ Sound ☐ Cracked ☒ **Leaks**

**Chimney / Frame Adjustment** ☒ Exists Material: **Brick** ☐ Parged Height: **9** (in.)

Condition: ☐ Sound ☐ Cracked ☐ Root Intrusion ☒ **Loose Brick** ☐ Deteriorated

Infiltration: ☐ None ☒ **Joint** ☐ Cracks ☒ **Mortar** ☐ Roots ☐ Wall
